IMPERIAL COLLEGE  
EXPEDITION  
TO  
KENYA (1981)

(Published November 1982)

THE HYDROLOGICAL STUDY

Marek Banasiak

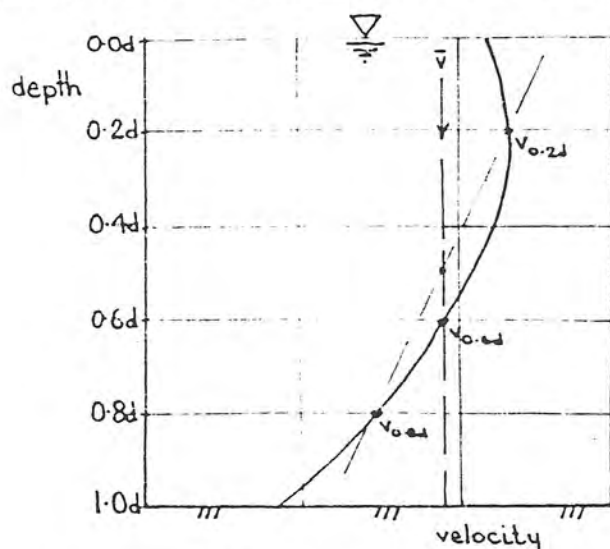
Fig.1 A typical velocity profile

At each vertical along the cross section we were looking to measure the average velocity of water in that vertical. Two standard estimates for this were (i) simply the water velocity at 0.6 depth and (ii) the average of the water velocities at 0.2 depth and 0.8 depth.

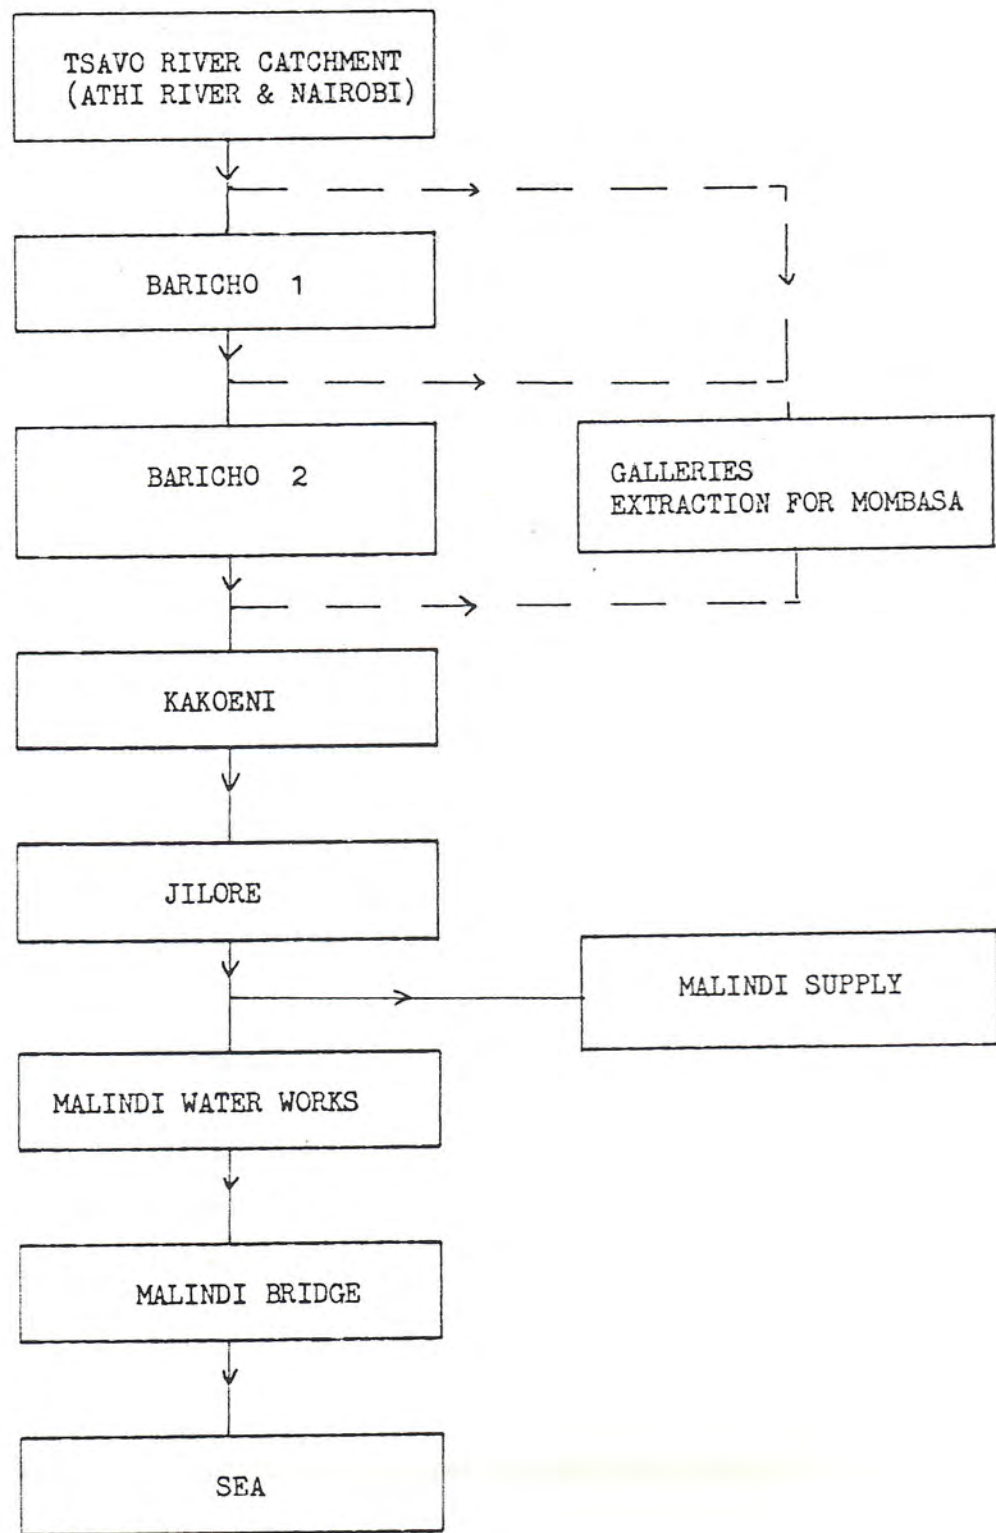
Fig. 2 Flow Chart representing the Hydrological cycle of the Sabaki River.

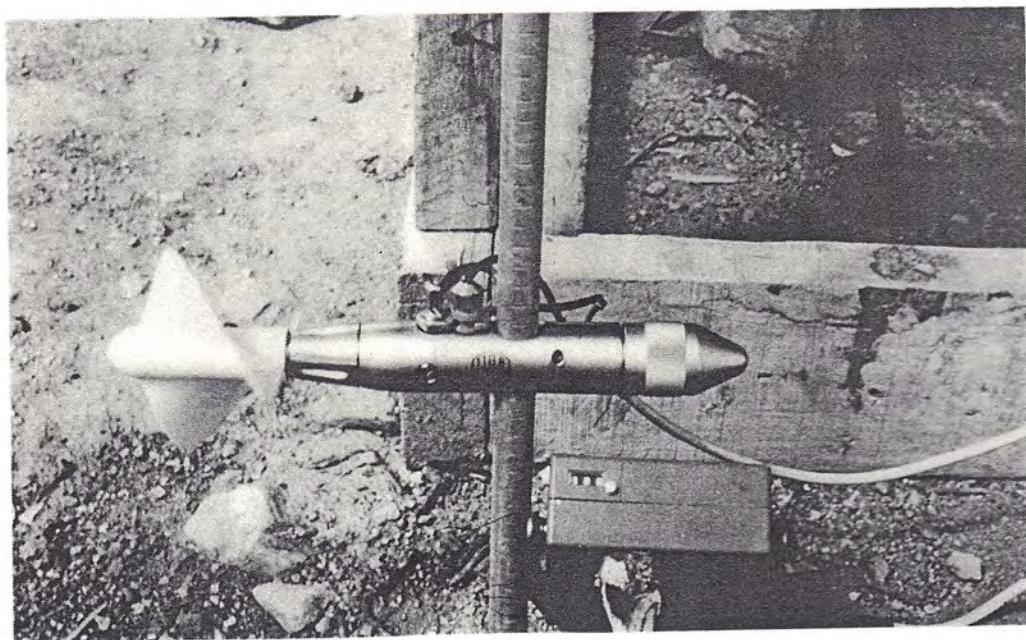
P.2. The current meter used.

- 11 Aug. - The contact to the negative terminal on the meter is loose and is fixed. After a short practice we are all set to go.
- 12 Aug. - An enthusiastic start with two sets of flow measurements. The site Baricho (1) however may be affected by the amount that is being abstracted from the galleries of the Weir. The first measurement has no 6/10d velocity measurements but 4/10d measurements. The second is a shortened version of the full measurement; only at every third knot.

- 20 Aug. - The positive contact this time, breaks and requires soldering. The flow measurement is therefore useless since it is only  $\frac{1}{2}$  complete.
- 21 Aug. - An attempt to repair the current meter was inadequate and it means another day is wasted just lying in the sun. Luckily Mr. A. Scott says he can solder the contact for us. Nevertheless we selected a new site near Malindi Water Works.

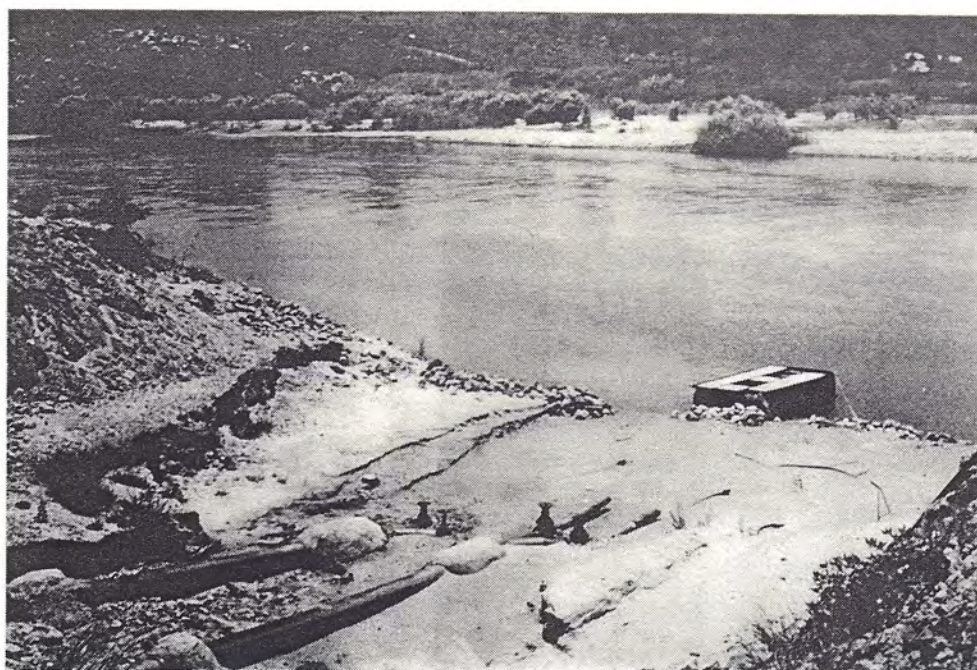
P.4. Metering site at Baricho

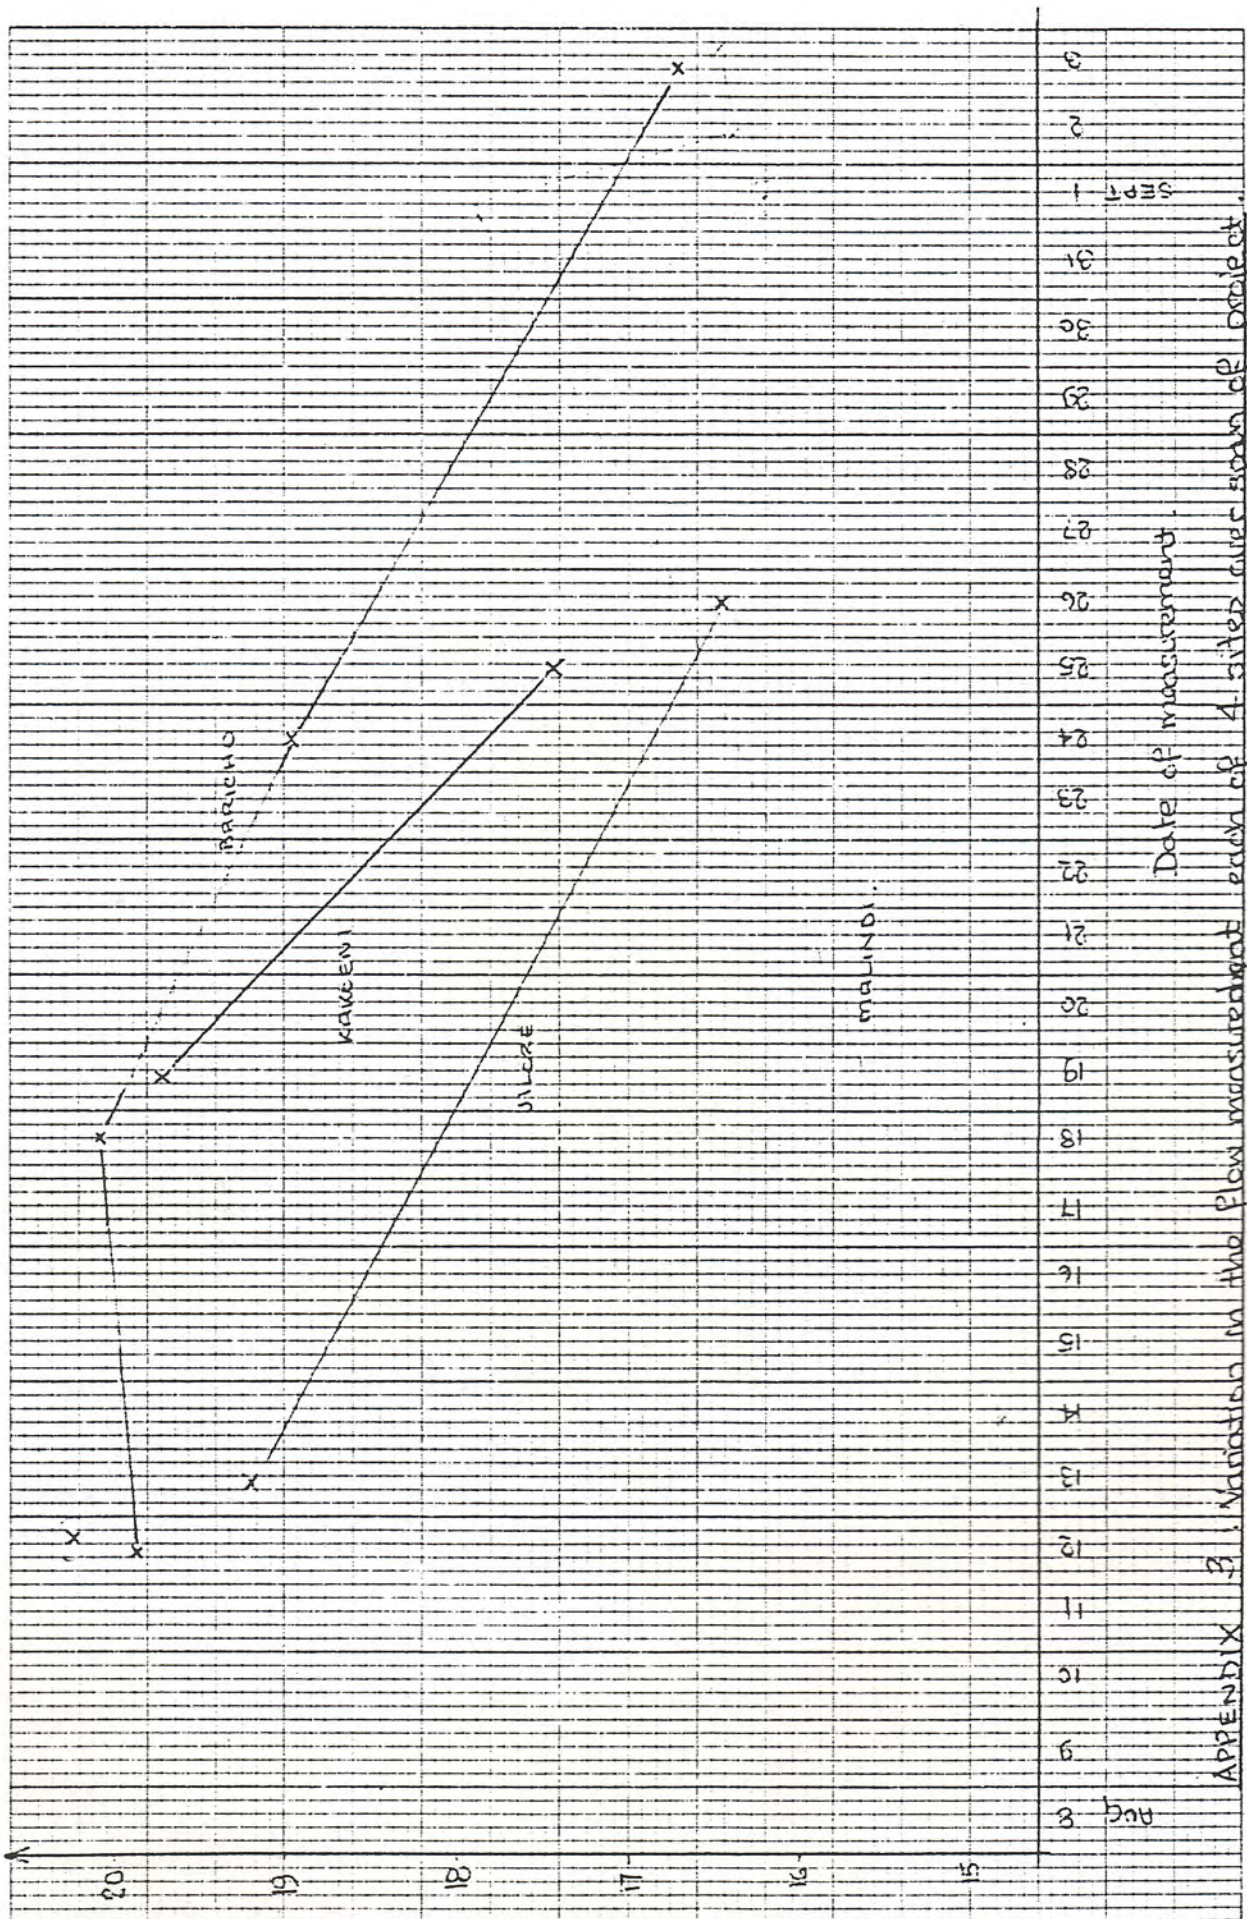
APPENDIX 3: Variation in the flow measured each of 4 sites over span of project.

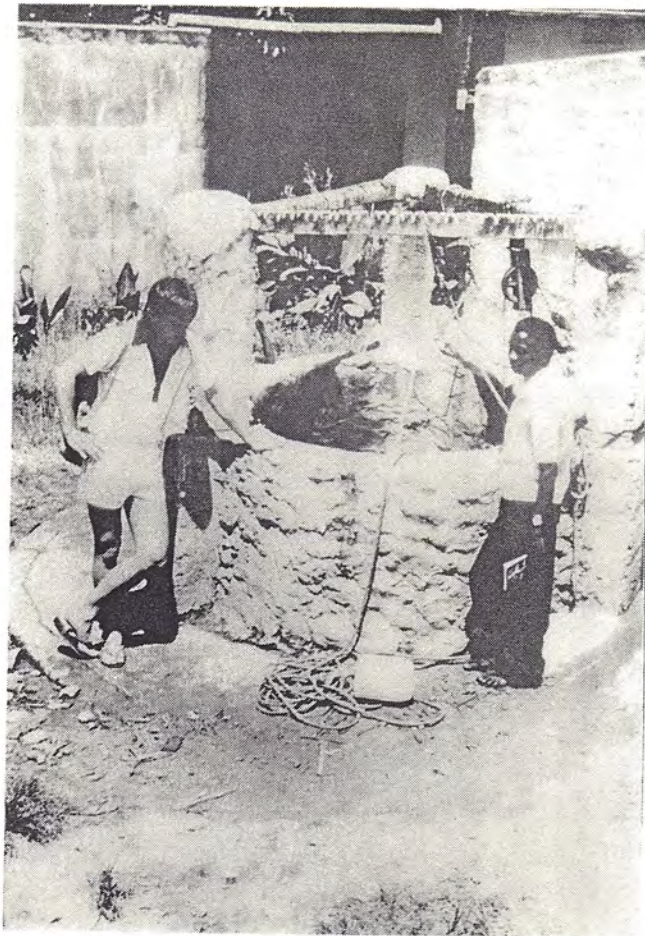
P.1. Typical Well

A typical well is 15 - 20m deep and 1.5 - 2m in diameter. The walls of the well in the clay/surface soil layer are lined with local stone: this is provided for support and to prevent contaminated ground water near the ground surface percolating into the well. A wall of stone and cement of height 1m protects the mouth of the well and a poorly constructed apron of the same material surrounds the mouth of the well: the apron extends about 1m from the well but is well worn and eroded and stands at the same level as the surrounding ground surface.

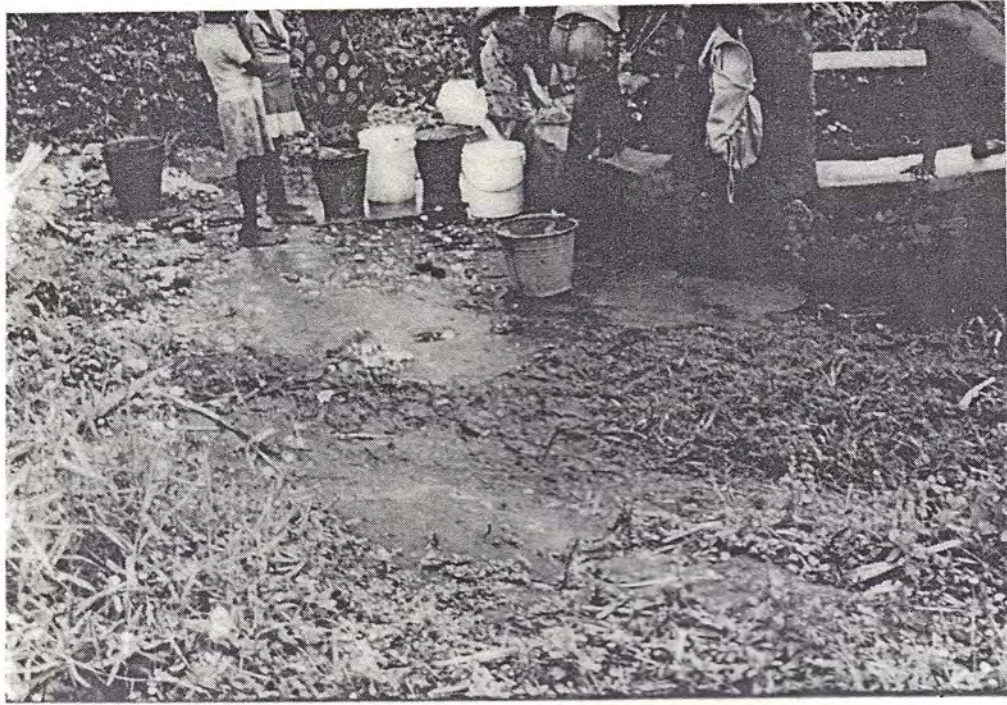
P.3. Bad drainage around well

Another problem in Bureni is leakage from the storage tank and tap. This leads to flooding since the area around the well is poorly drained, making water collection unpleasant and creating a possible health risk.

- (5) Aprons. These are poorly constructed and do not allow adequate drainage away from well mouth.
- (6) Impermeable linings. These tend to be of poor quality and in some cases the mortar has been worn away allowing seepage of contaminated surface water into the wells.

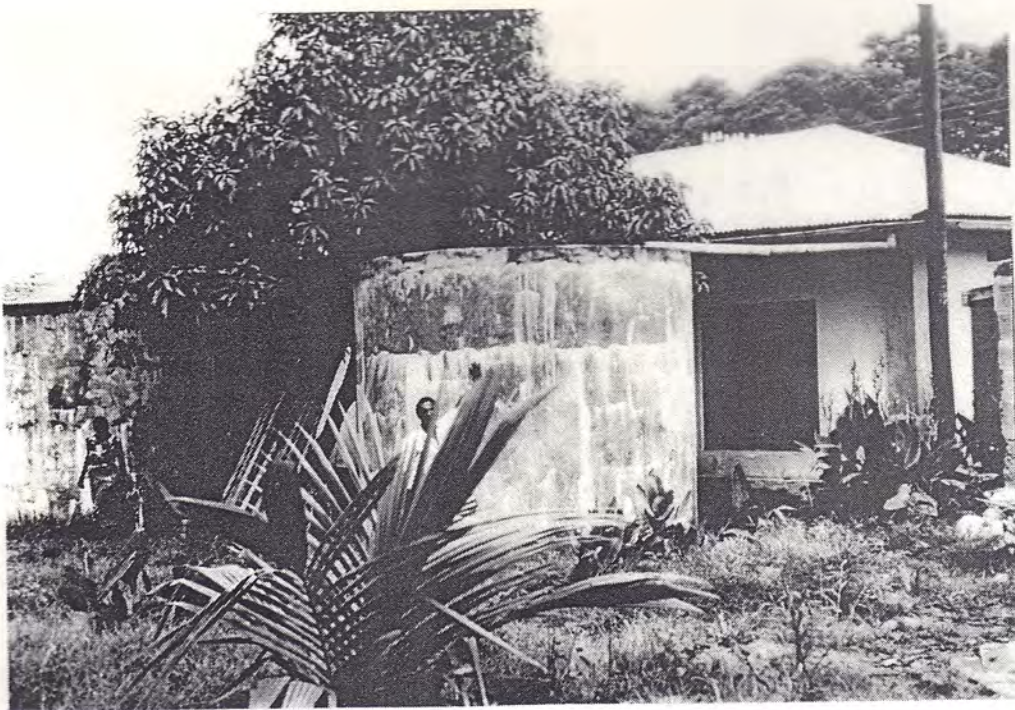
P.4. Water tank for collecting rain water.

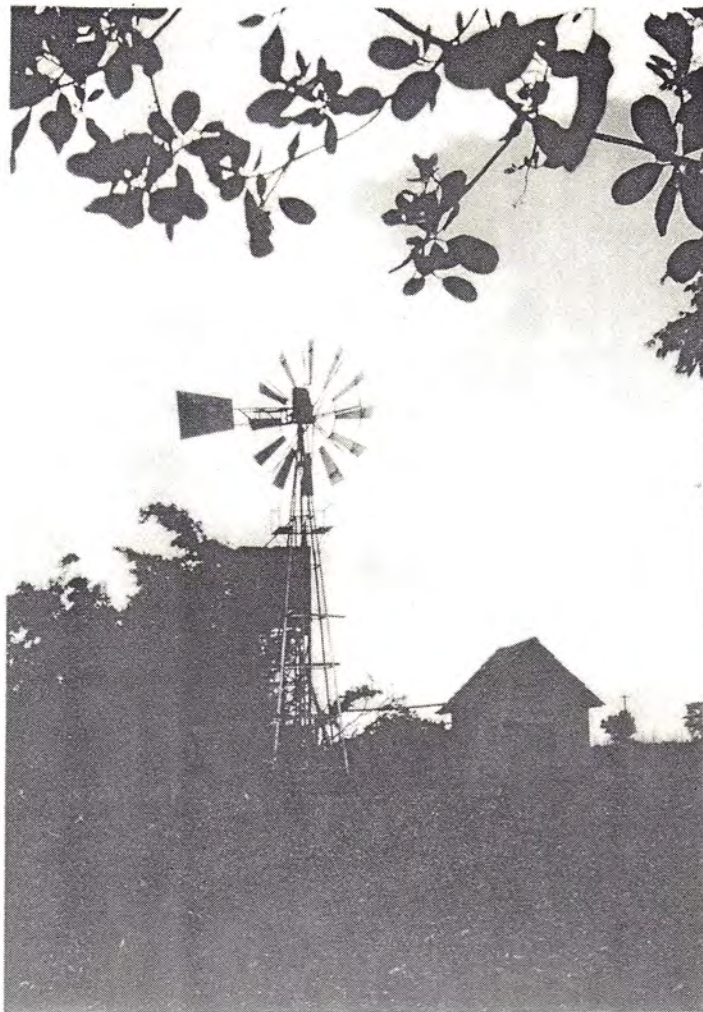
P.5. Wind pump on  
Vipingo estate.

The wind pump saves manual extraction. The well is covered and thus relatively hygienic since it prevents contamination by users and prevents entry of dust and dirt. However leakage is often a problem, (see section 4.1.7).

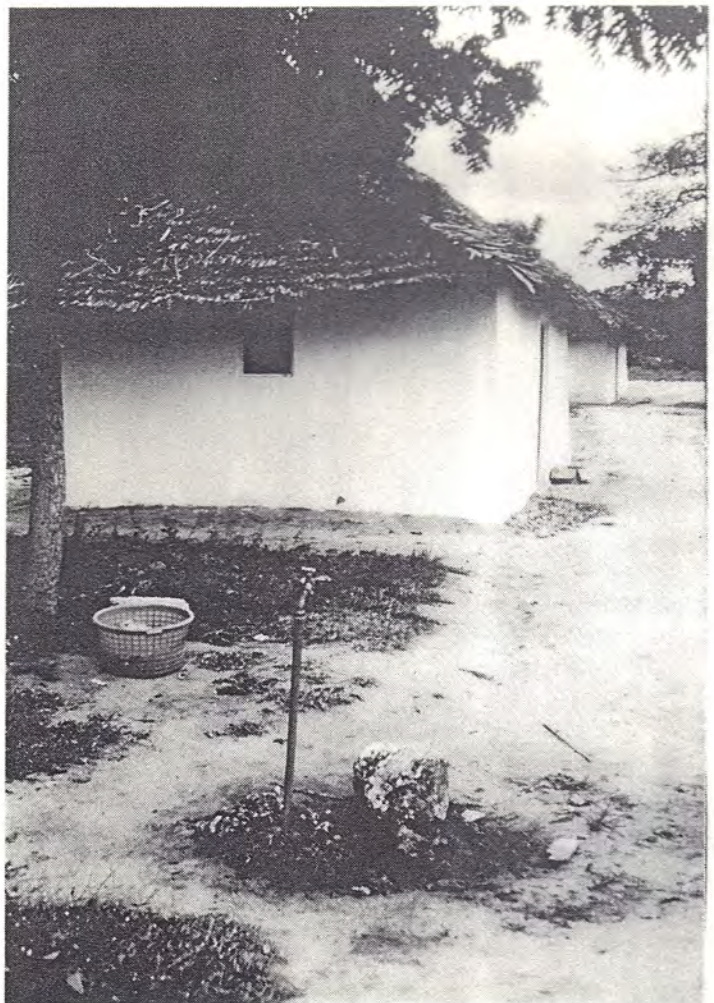
P.6. Typical stand  
pipe.

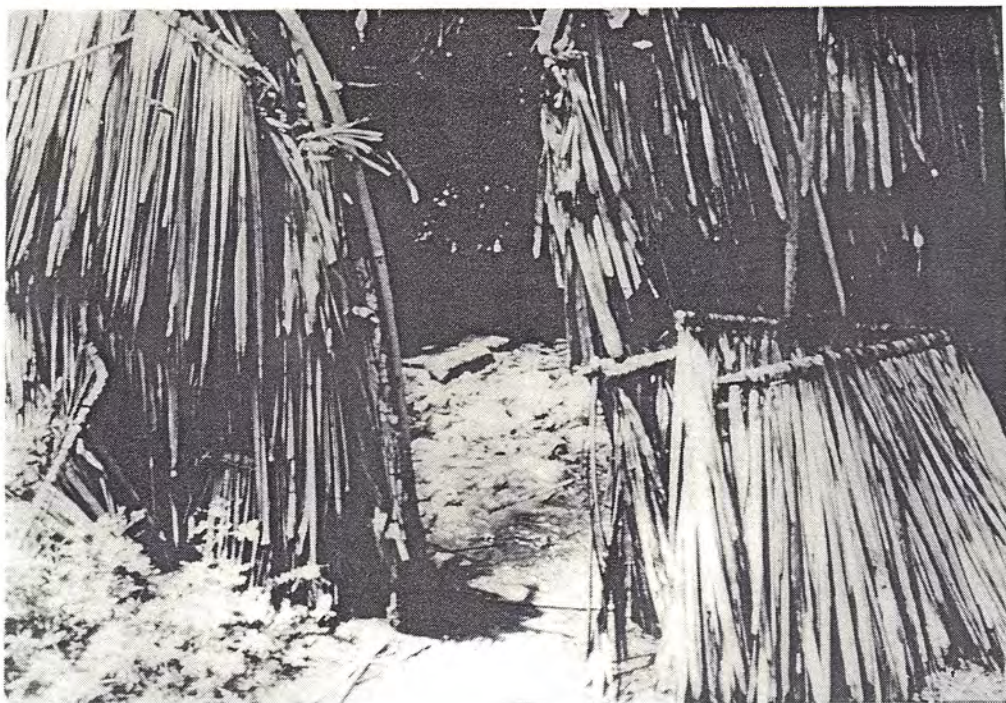
p.7. Boma (urinal)

These structures are open, poorly constructed and lack any form of proper drainage. Not only do these structures transmit disease to their users but, under rainy conditions, often flood resulting in large areas of the surrounding ground being contaminated by "pools" of waste and possibly also contaminating nearby water supplies.

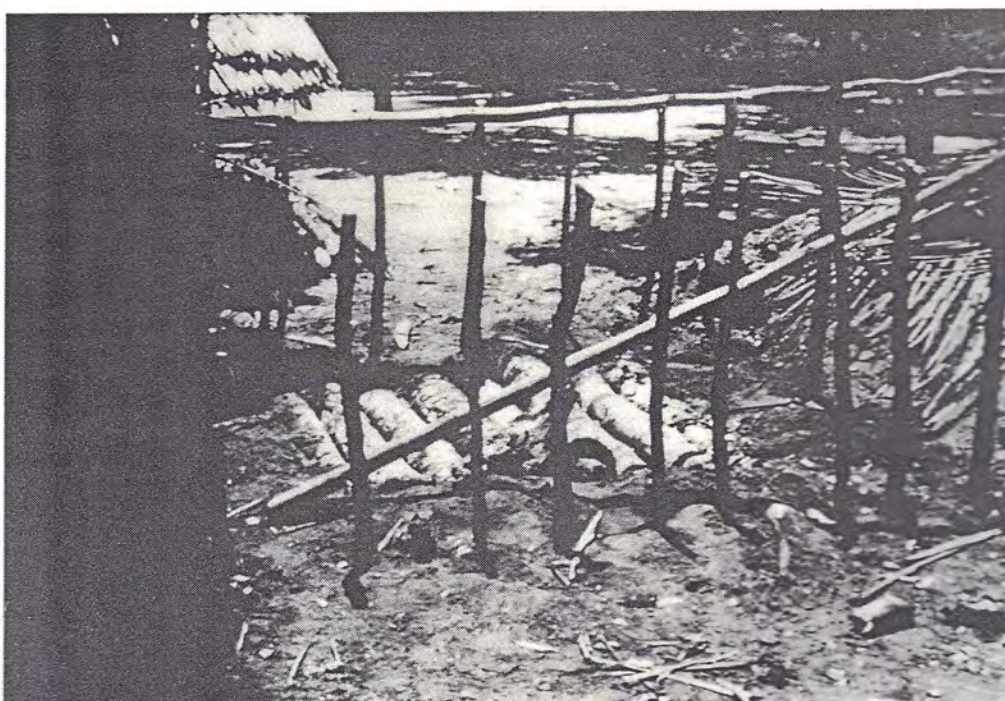
p.8. Latrine (open pit type)  
under construction.

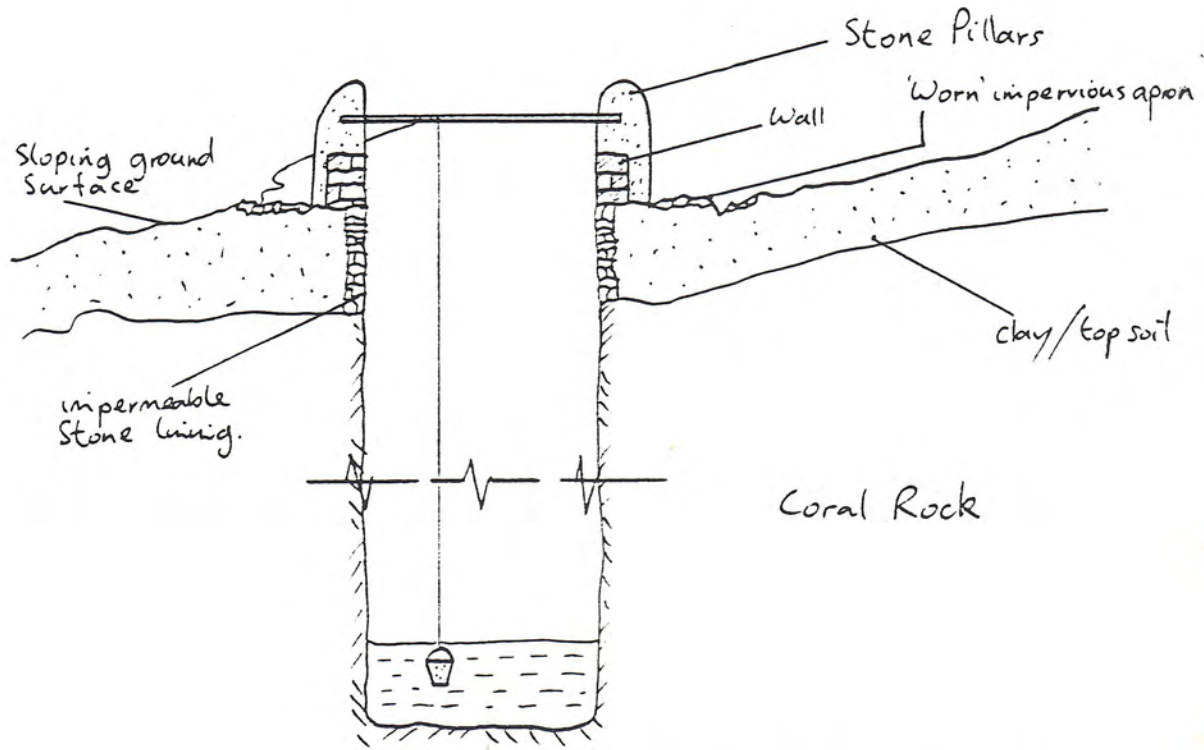
Diag. 3 Typical Hand Dug Well. (not to Scale)

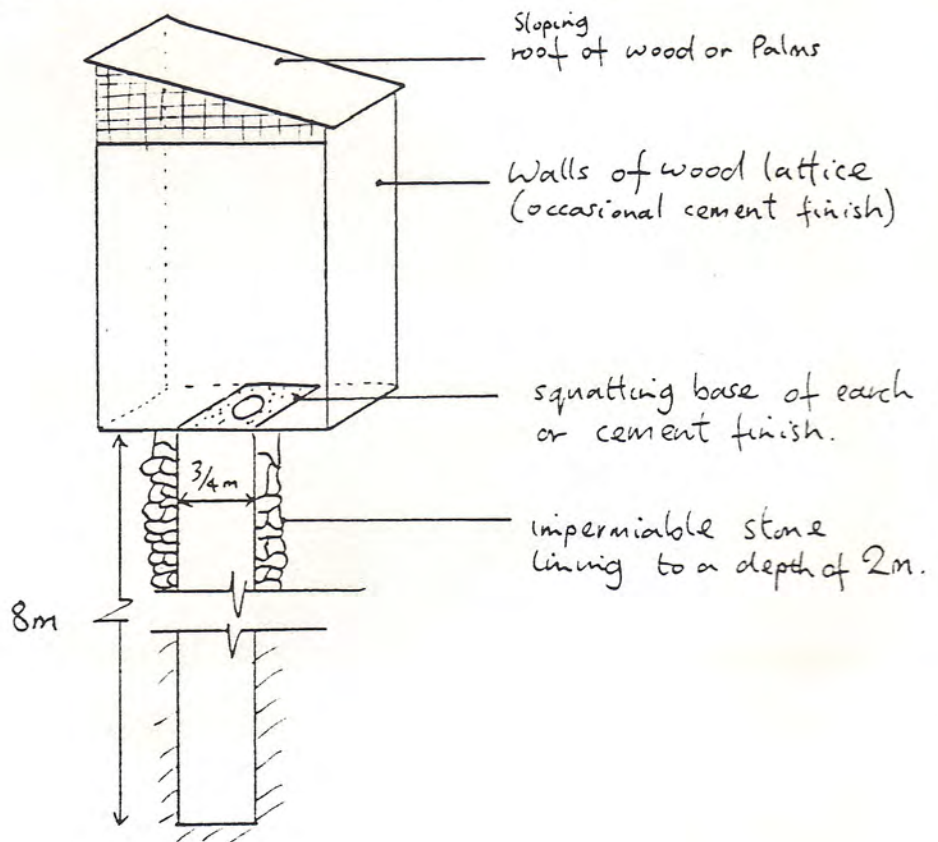
Diag. 4. Ideal Pit Latrine
